***The Bald Eagles of
Stony Creek Metropark, Inwood Trails
Joan Bonin, Eagle Observer, and Documentarian***

© Joan Z. Bonin

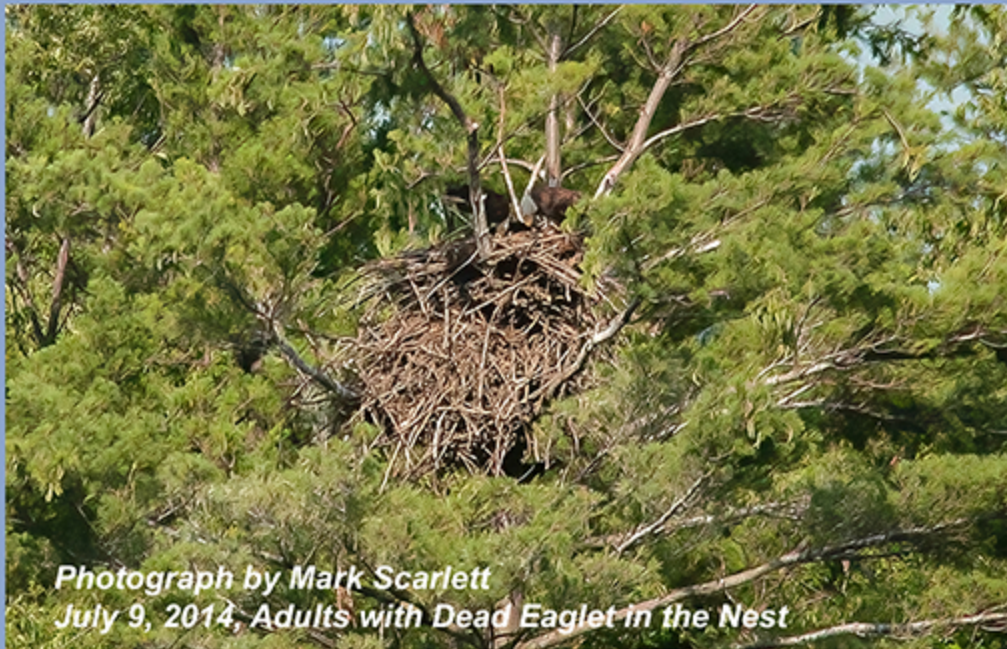
*Photograph by Mark Scarlett
July 9, 2014, Adults with Dead Eaglet in the Nest*

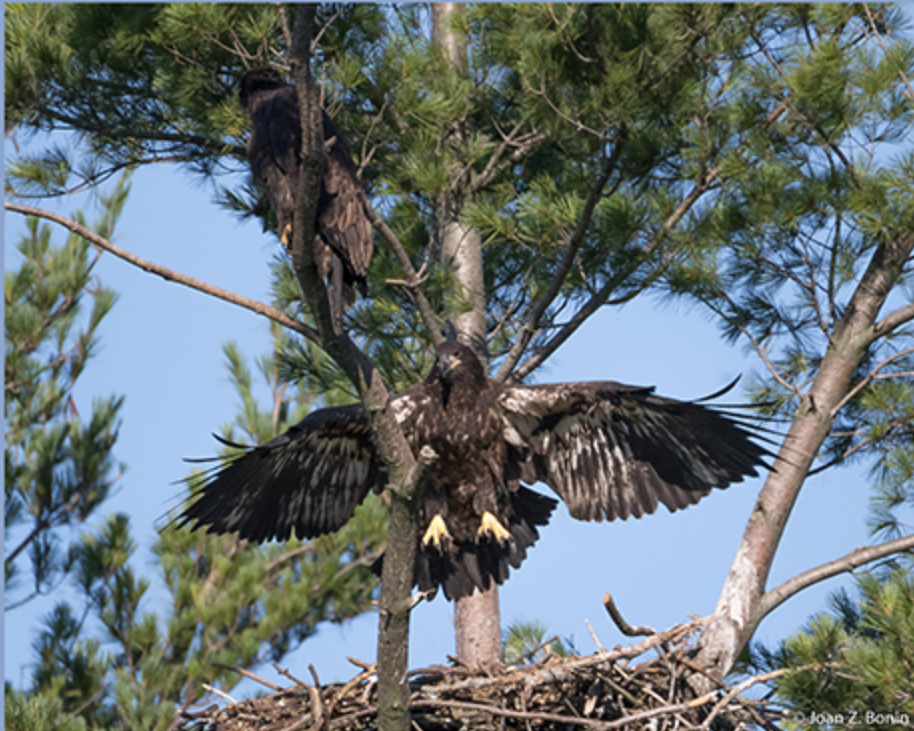
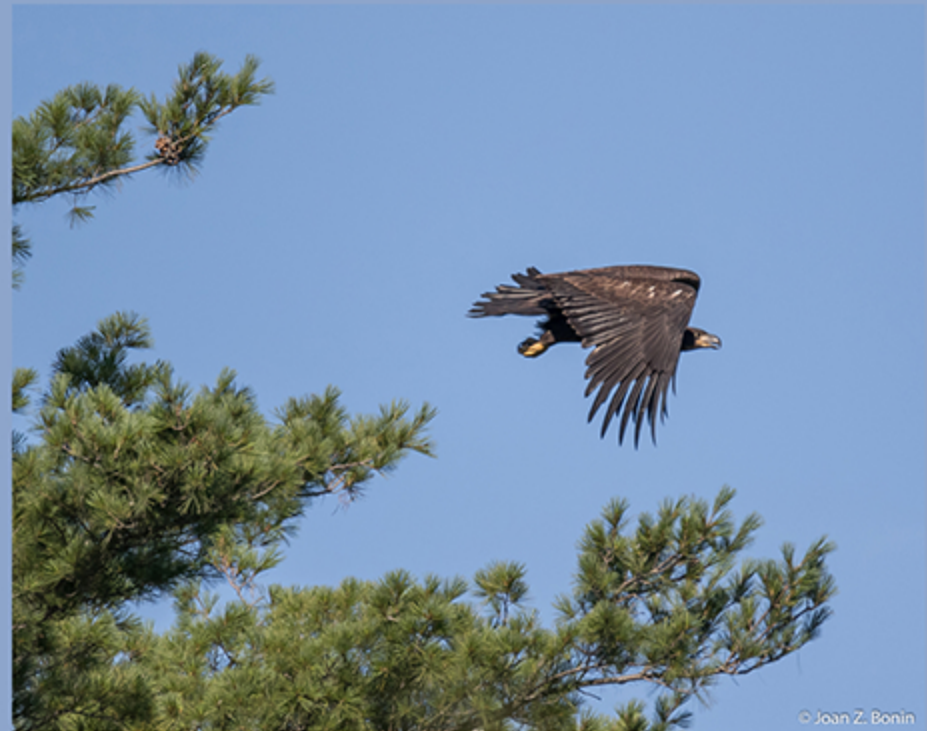
Nest Configuration 2013-2023

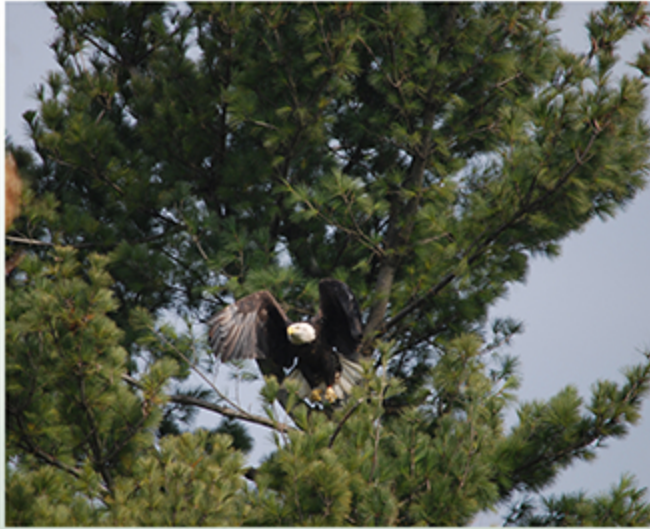
The female Bald Eagle at Winter Cove dated 11/09/2012 by Robin Haworth

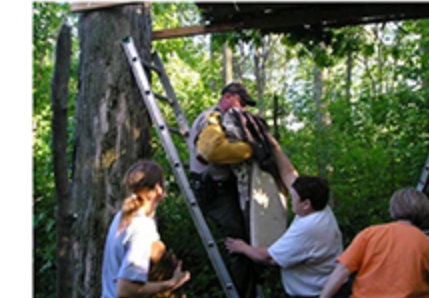
Jan Ferrell, local naturalist, helps cover an eagle in 2008 as Richland County Wildlife Officer Greg Wasilewski takes the bird up to the makeshift nest. Volunteers made after the nest and two eaglets fell 60 feet to the ground. (Photo: Submitted photo)

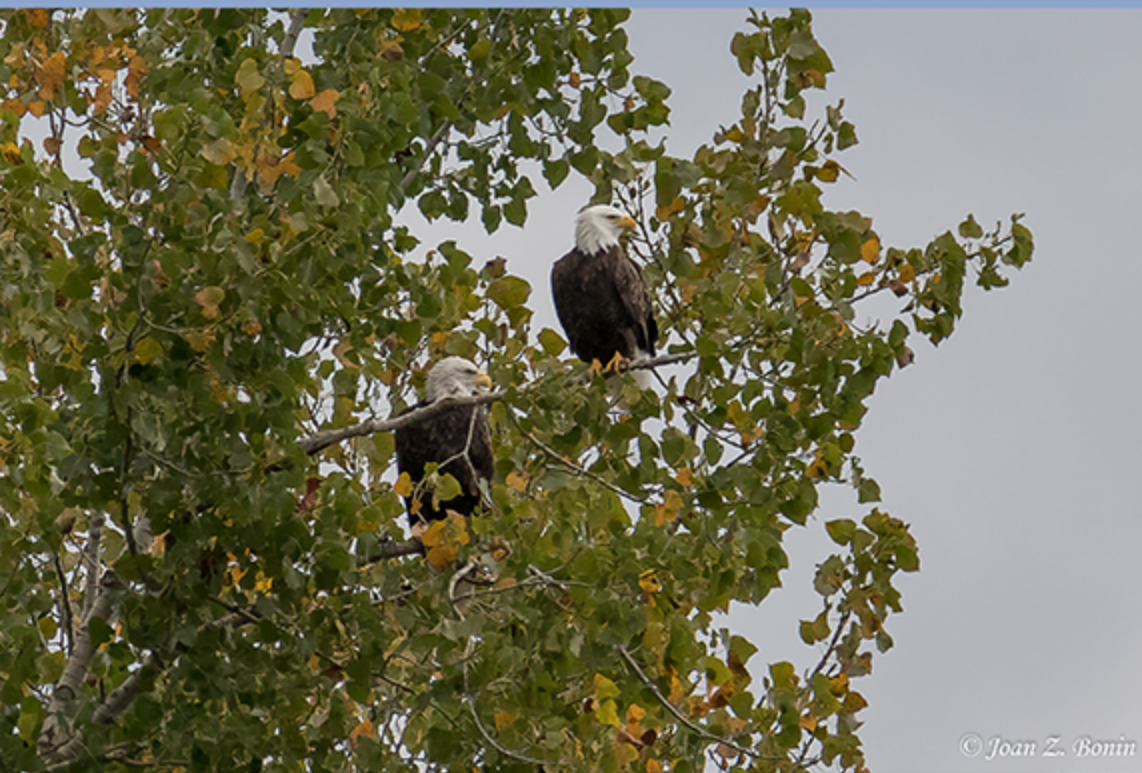
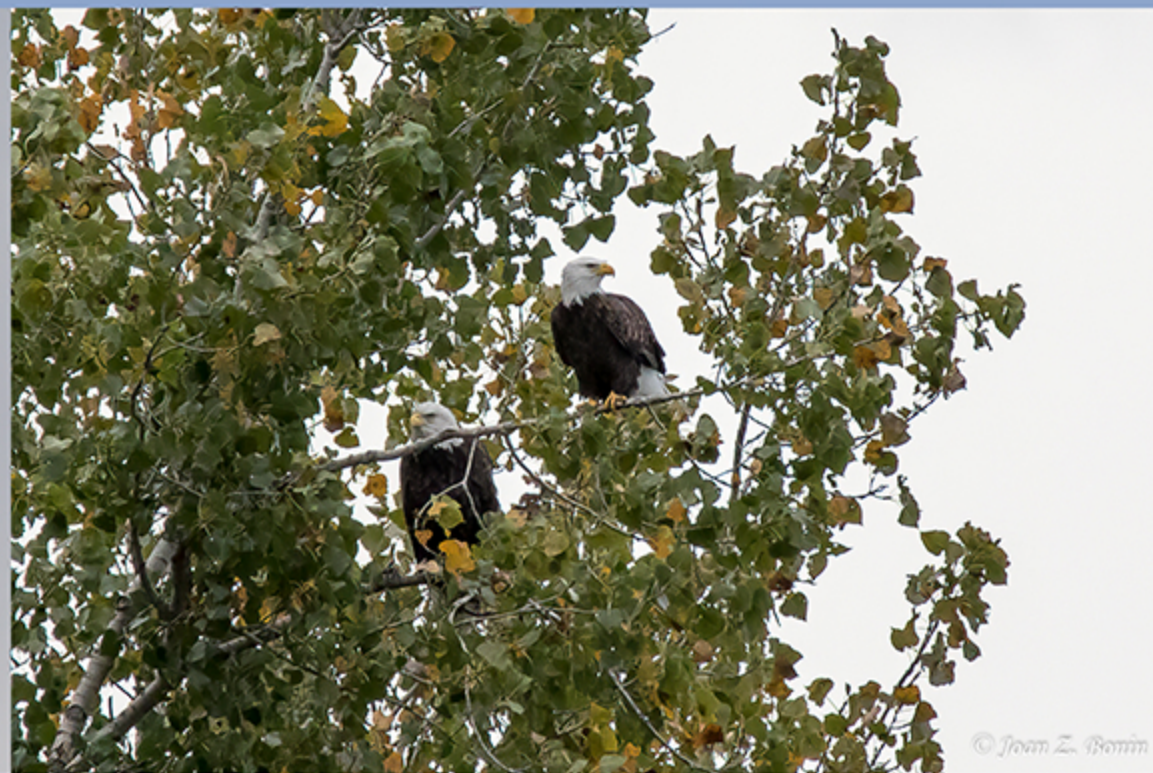
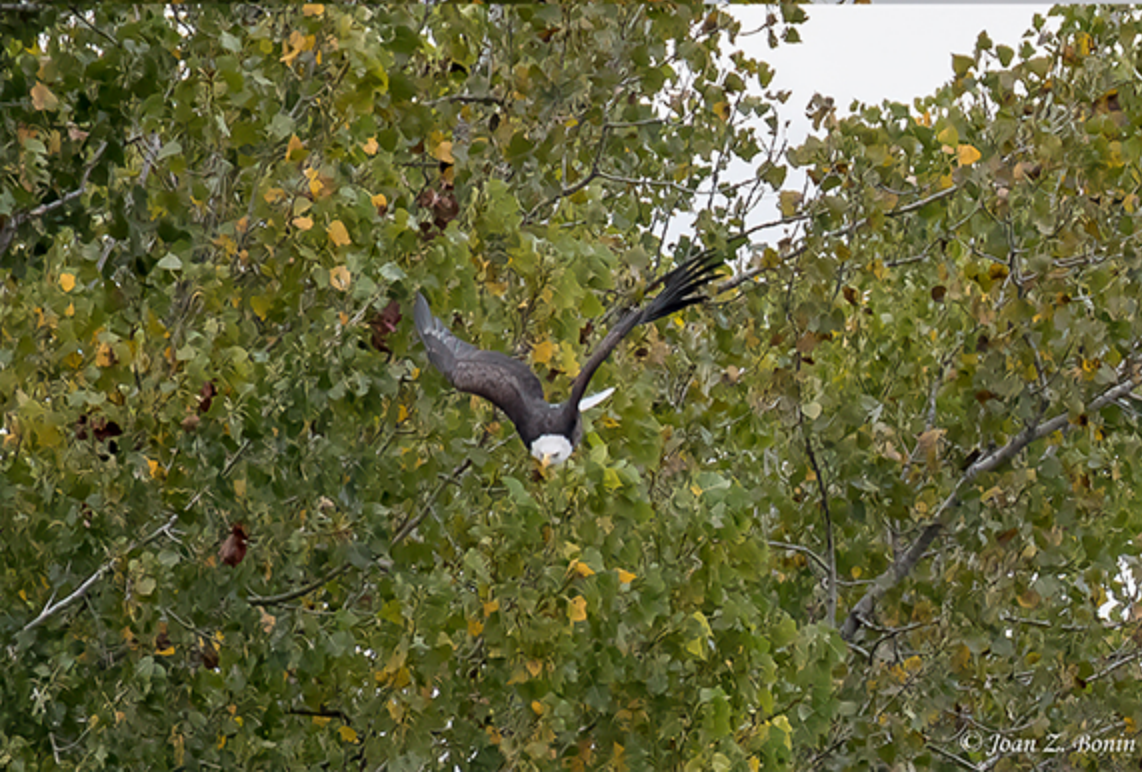
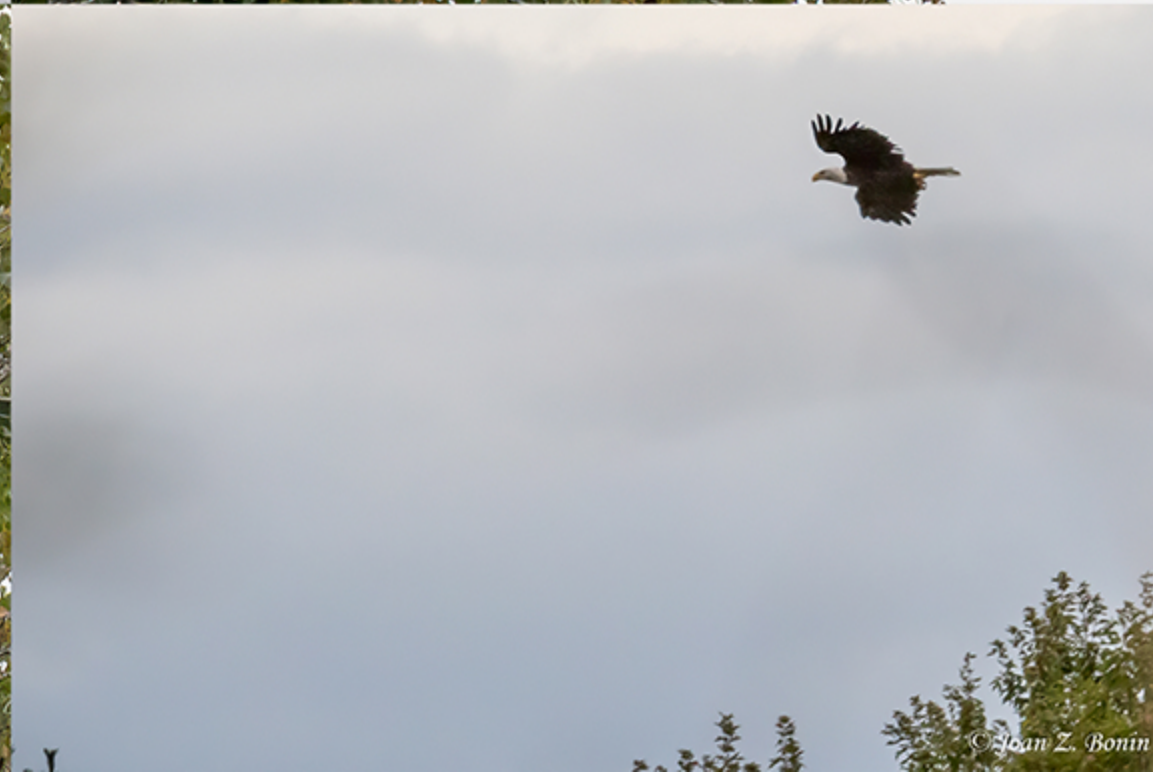
New Female Bald Eagle 2021 Nesting Season
